# ENVIRONMENTAL QUALITY OF WILMINGTON AND NEW HANOVER COUNTY WATERSHEDS, 2012

Michael A. Mallin, Lauren E. Bohrer, Matthew R. McIver and Stephanie Protopappas

CMS Report 13-01  
Center for Marine Science  
University of North Carolina Wilmington  
Wilmington, N.C. 28409  
[www.uncw.edu/cms/aelab/](http://www.uncw.edu/cms/aelab/)

May 2013

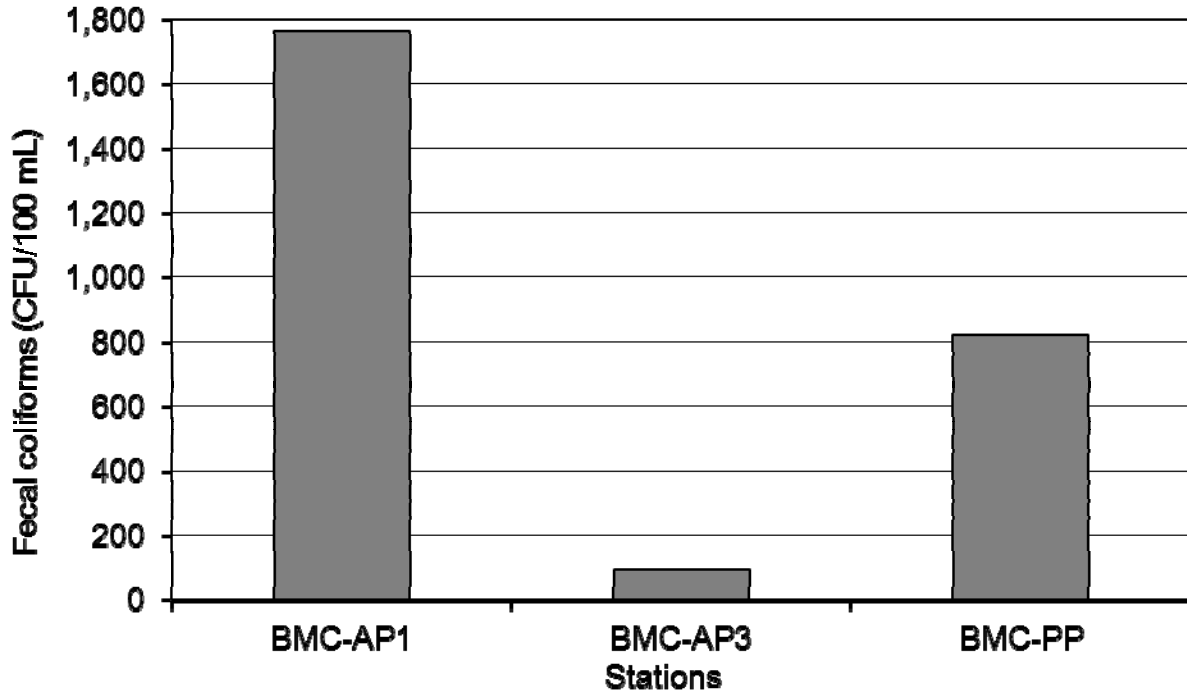
**Figure 4.2. Fecal coliform bacteria geometric means for Burnt Mill Creek, 2012**

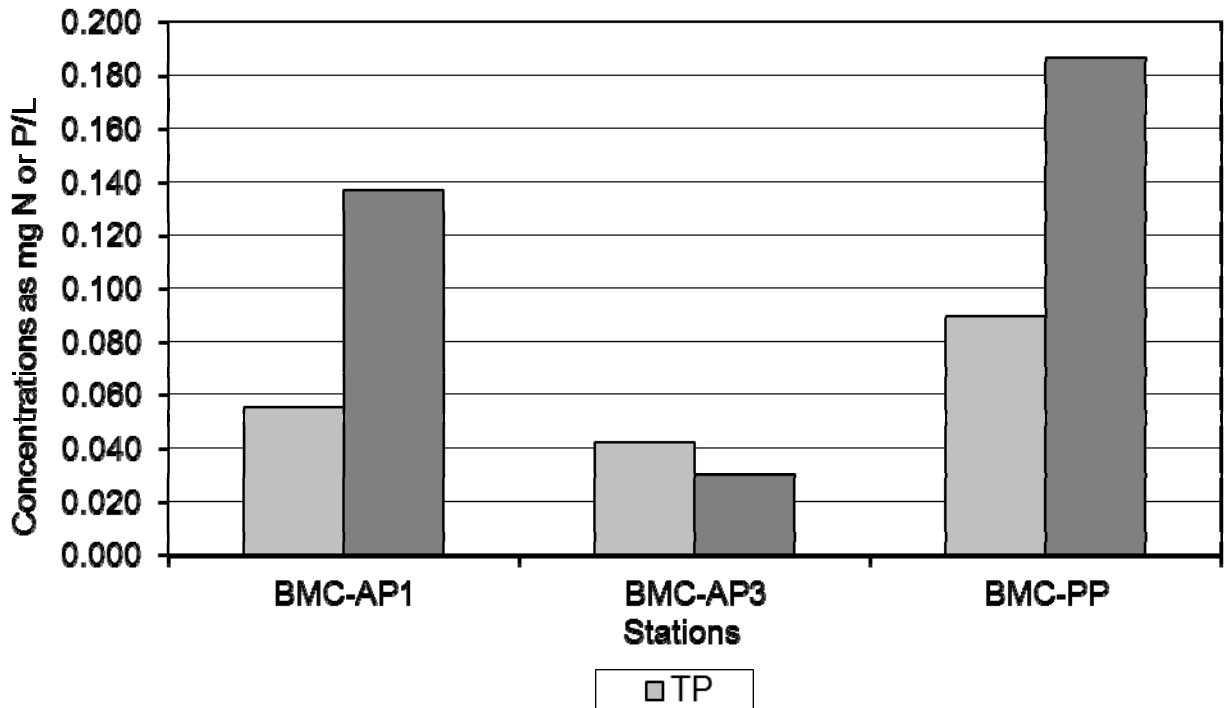
**Figure 4.3. Average total phosphorus and nitrate concentrations by station for Burnt Mill Creek, 2012**

An important question is what drives algal bloom formation in Burnt Mill Creek? Nitrate concentrations were somewhat elevated at BMC-PP, while phosphorus concentrations were low. Examination of inorganic nitrogen to phosphorus ratios (Table 4.1) shows that median N/P ratios were 15.5 and mean ratios were 15.1. In waters where the N/P ratio is well below 16 (the Redfield Ratio for algal nutrient composition) it is generally considered that algal production is limited by the availability of nitrogen (i.e. phosphorus levels are sufficient); where N/P ratios are well above 16, additions of phosphate should encourage algal blooms. If such values are near the Redfield Ratio, as at BMC-PP, inputs of either N or P could drive an algal bloom. Thus, control of inputs of both N and P would help reduce algal blooms in lower Burnt Mill Creek.

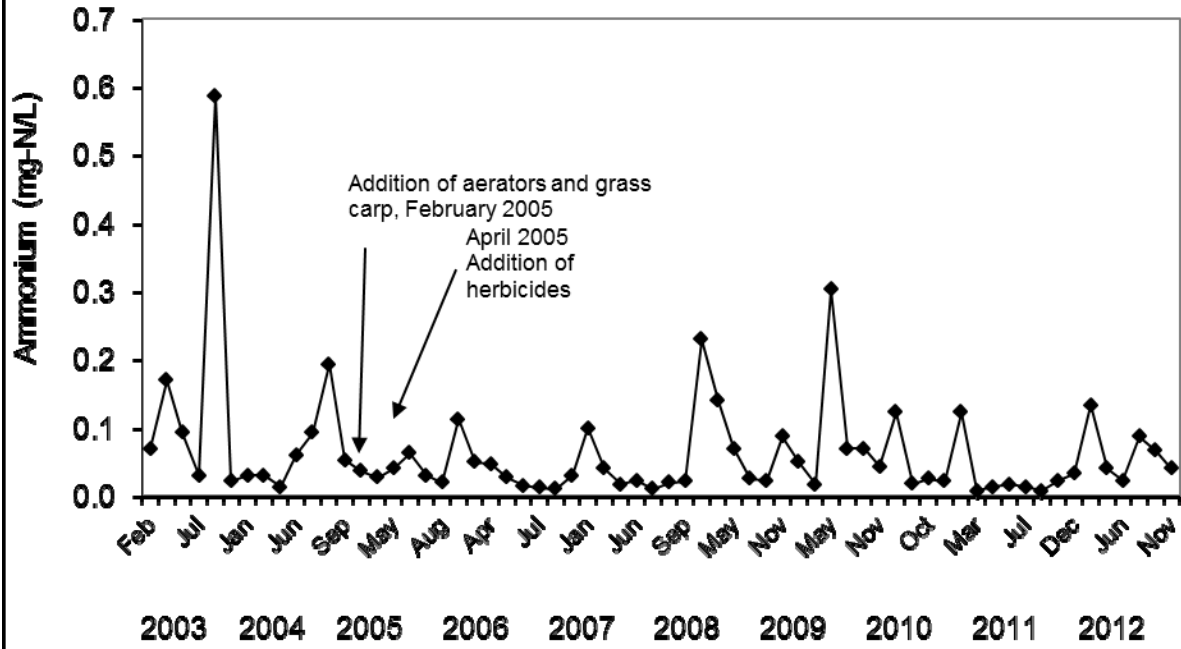
Figure 6.3. Average ammonium concentrations in Greenfield Lake 2003 - 2012.

Water column nutrient concentrations did not appear to change notably after the introduction of grass carp or use of herbicide. Certainly ammonium, an excretory and decomposition product would be expected to rise following the consumption and death of large quantities of plant material. Likewise phosphorus did not increase, although it is a common excretory product. However, ammonium (like orthophosphate) is readily used as a primary nutrient by phytoplankton. Nutrient addition bioassay experiments have demonstrated that phytoplankton growth in this lake is limited by nitrogen (Mallin et al. 1999). It is likely that ammonium produced by fish excretion or dying plant material was utilized by phytoplankton to produce the excessive algal blooms that characterized the lake in 2005 and 2006. The phytoplankton blooms were dominated by blue green algae (cyanobacteria) including species containing heterocysts (formerly called heterocysts). These species have the added ability to utilize these structures to fix atmospheric nitrogen into a useable form when phosphorus is replete. Thus, while large amounts of macrophyte material disappeared from the lake, some of the resultant nutrients were utilized by phytoplankton to produce the blooms in the two years after the largest treatments.

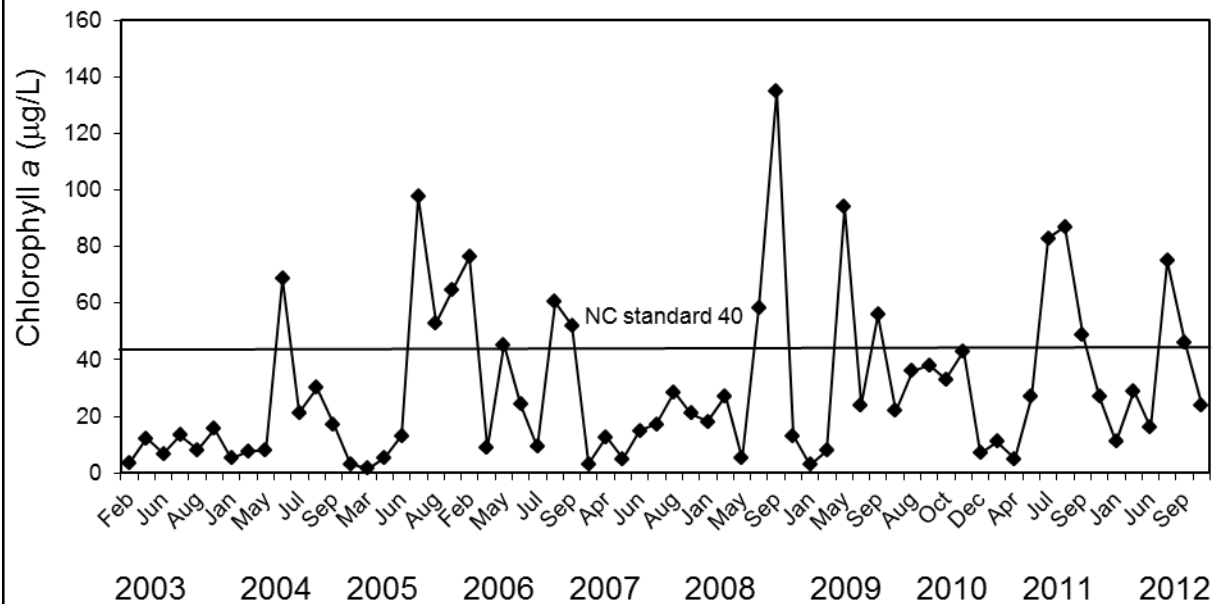
Figure 6.6. Average chlorophyll a concentrations in Greenfield Lake, 2003-2012.

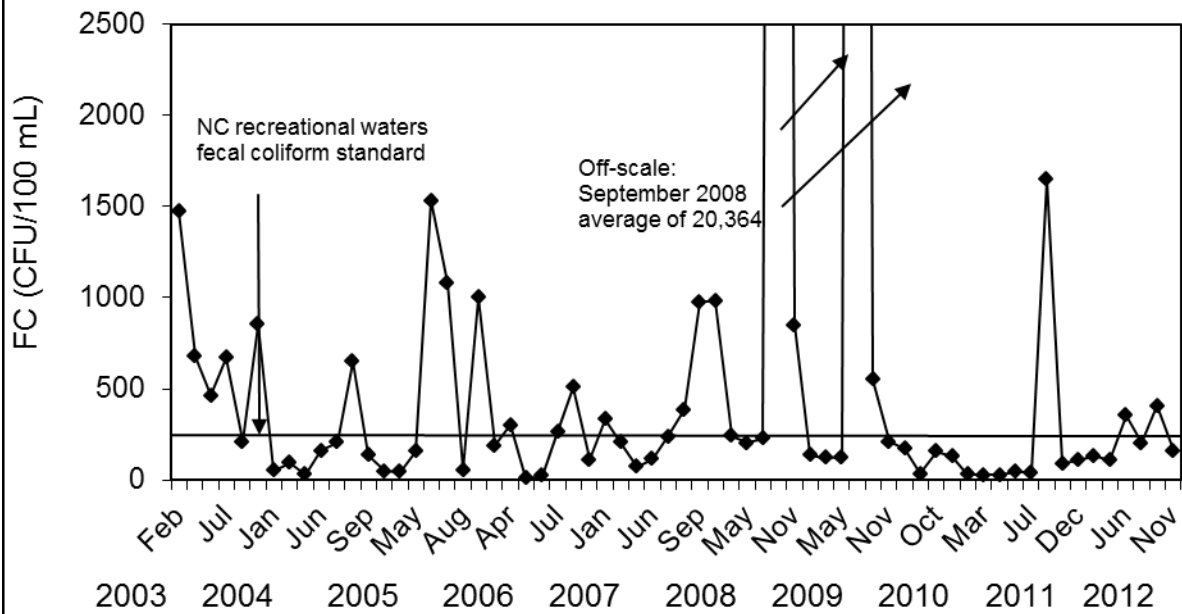
Figure 6.8. Average fecal coliform concentrations in Greenfield Lake, 2003-2012.

The continuing problems with high fecal coliform bacteria do not appear to be related to any of the restoration activities. Fecal coliform bacteria enter the environment from the feces of warm blooded animals, so it is possible that increases in waterfowl, or dogs brought to the lake by their owners, or feral cats could lead to increased fecal coliform bacteria counts, but we have no data to support this speculation either way. Likewise on rare occasions large pulses of fecal bacteria have appeared in the lake or tributaries, potentially related to either sewage leaks or spills, or illicit connections. We do re-emphasize that fecal coliform counts in 2010 were the lowest in several years. In 2011 and 2012 Greenfield Lake had generally low fecal coliform counts except for a large peak in August 2011(Fig. 6.8).

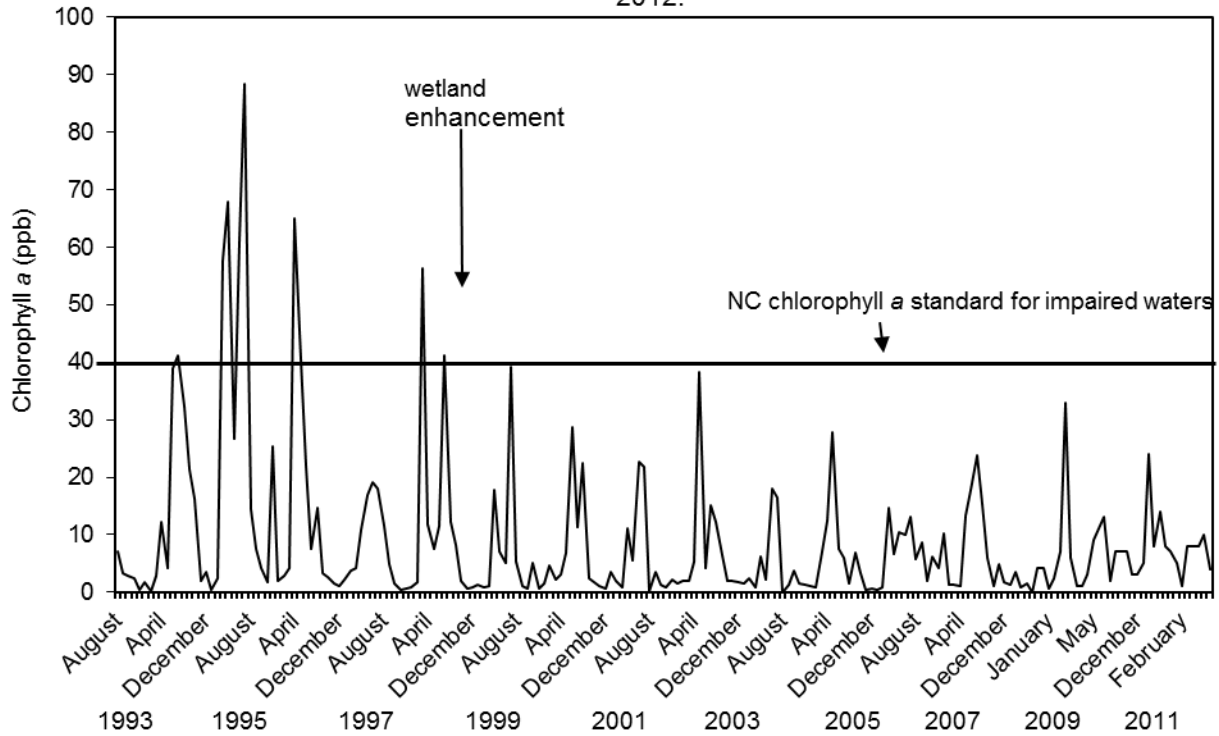
Figure 8.2. Chlorophyll a concentrations (algal blooms) in Howe Creek below Graham Pond before and after 1998 wetland enhancement in upper Pond, 1993-2012.
